## 7.0: Quarterly Dam Safety Report

The purpose of this report is to update the Operations, Planning, Information & Technology Committee of the Board of Directors on key dam risk management activities during the period from January 1 to March 31, 2024 (F2024 Q4) and to provide reasonable assurance that the safety of dams operated by BC Hydro continues to be managed to the established guidelines and criteria of the Dam Safety Program. To keep the Committee as fully abreast of the Dam Safety Program as possible, some notable developments that took place after March 31, 2024, but before the completion of this report have also been included.

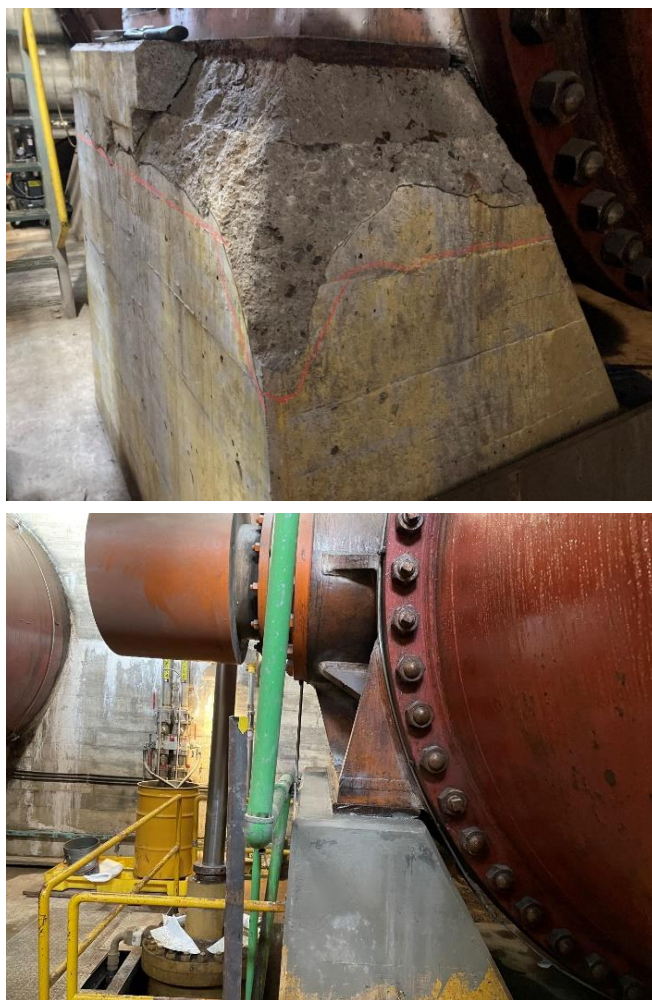
One of the late additions was to repair deteriorated concrete on the Bridge River 2 Penstock Inlet Valve pedestals. Because these pedestals are indoors, the work could be completed over the winter. Stations Maintenance Engineering developed the repair procedure and BC Hydro Construction Services performed the repairs. See photos in Figure 4 at right.

**Figure 4** Top: deteriorated concrete pedestal at Bridge River 2 Generating Station. Bottom: concrete pedestal after completed repairs.

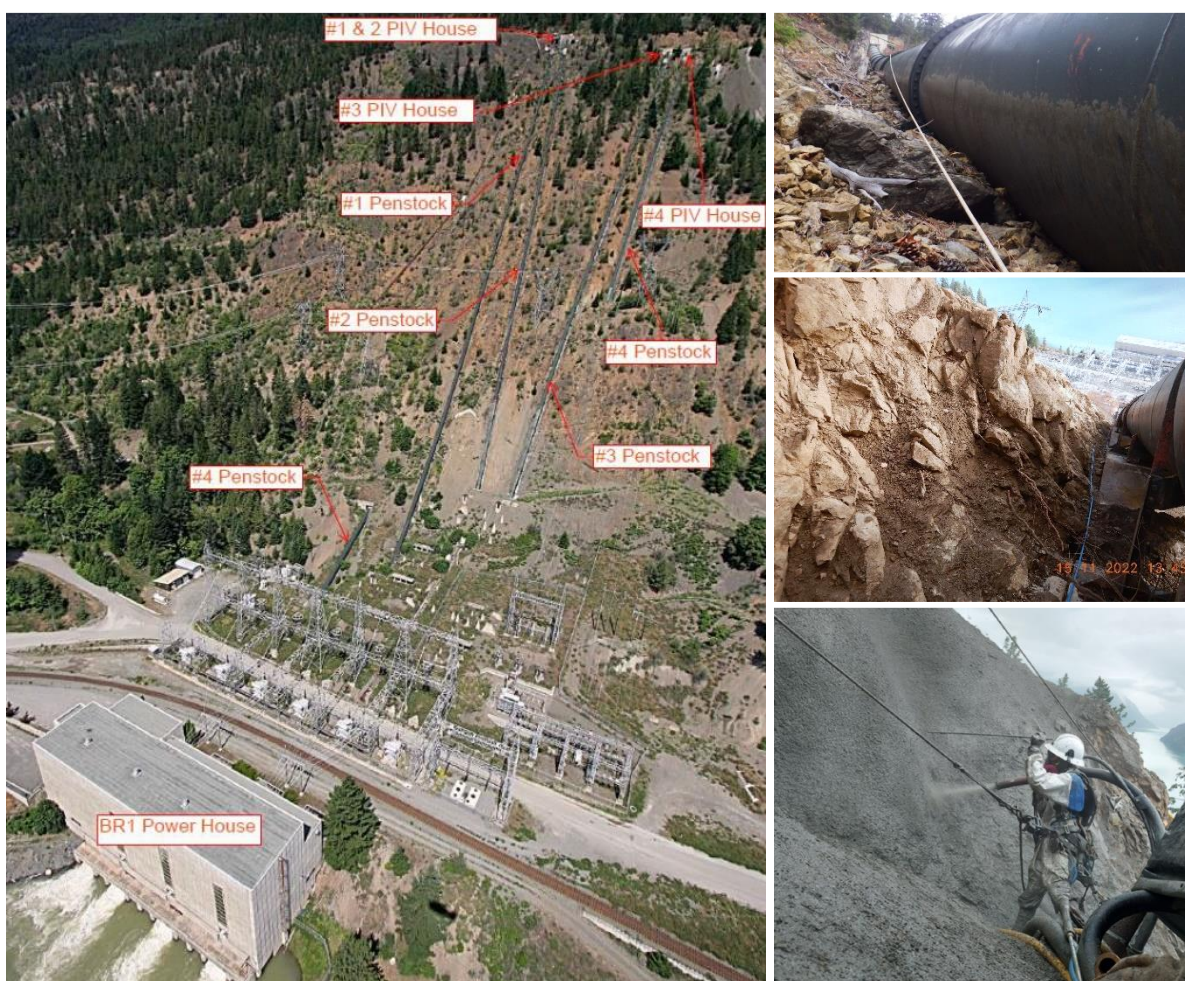
The concrete foundations of the four penstocks at Bridge River 1 Generating Station have visible cracks and spalls, and their steel supports have physical defects such as corrosion and deformations due to rock impacts. Inadequate and deteriorated slope protection measures along the penstocks' alignment had led to much of the foundations and penstocks being buried in loose rock and other debris, preventing the necessary refurbishment of the foundations and steel supports and the planned recoating of the penstocks in 2026. This project was initiated in 2021 to remove the rock debris, refurbish the concrete foundations and steel penstock supports, and refurbish and upgrade the slope protection and stabilization works to ensure the continued serviceability of the penstocks.

**Figure 6** Refurbishment of the Bridge River 1 penstocks. Left: aerial view of the penstocks. Top right: accumulated debris prior to removal. Middle right: penstock trench after debris removal. Bottom right: shotcrete stabilization of penstock trench wall.

Debris removal was completed in May of 2023 and slope stabilization along the penstock alignments was completed in December of 2023. In F2024 Q4, Construction Services completed the penstock foundation refurbishment work in the powerhouse tunnels. A First Nations contractor has now mobilized to site to perform the penstock foundation refurbishment work on the slope. The project is forecasting to be in service in December 2024.

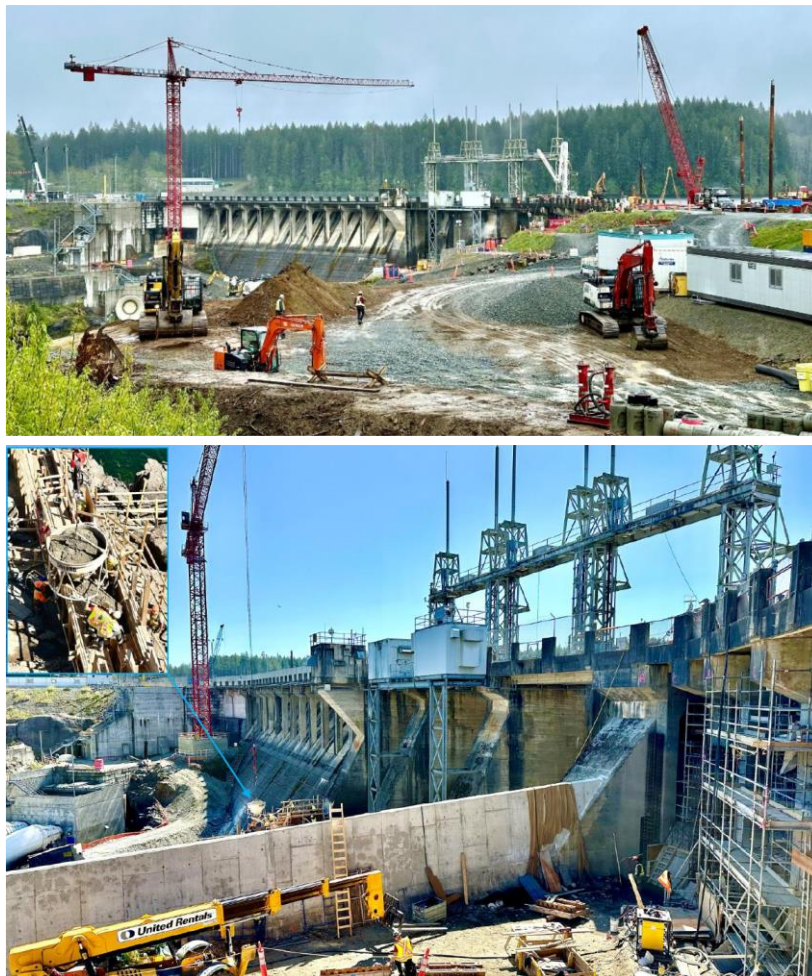
**Figure 7** Top: View of the North Earthfill Dam at John Hart, with the upstream berm densification work taking place on the far right and, in the foreground, preparations for the placement for the downstream berm. Bottom: the completed left training wall and concrete placement for the right training wall (inset).

On the North Earthfill Dam, in-water excavation and riprap removal has been completed and placement and densification of the dam’s upstream stabilizing berm is underway, as are preparations for the placement of the dam’s downstream stabilizing berm. On the Concrete Main Dam, construction to build a new right training wall, and place infill concrete under the roadway on blocks 13-15 on the left side of the spillway is underway, and construction to raise the spillway’s left training wall is complete.

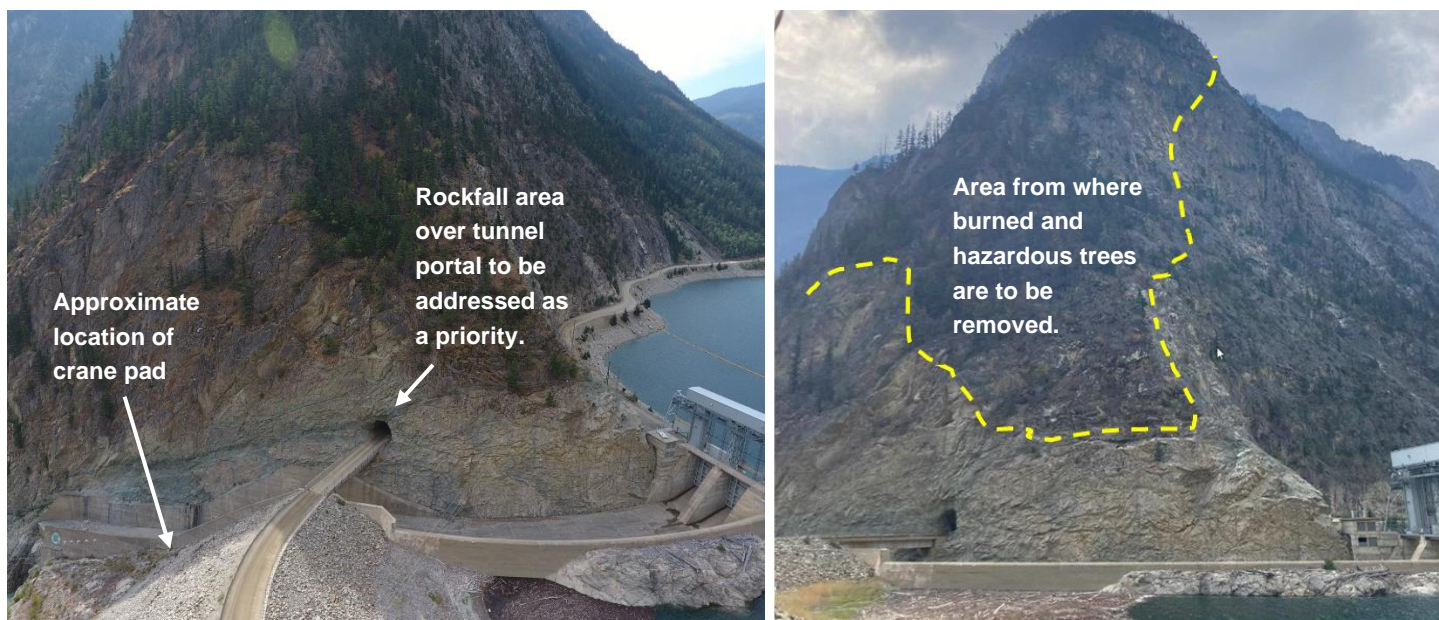
The full impacts of the rockslide on project scope and schedule are still to be confirmed. The project has added scope to complete removal of burned and hazardous trees from the slope due to the 2023 Casper Creek Wildfire and, as a priority, to address a small added rockfall area over the tunnel portal that presents a potential risk to workers and the public using the road. See Figure 8, below.

**Figure 8** Spillway chute and adjacent rock slope at Terzaghi Dam, with locations of project scope items identified.

The objective of this project is to sufficiently mitigate the hazard of rockfall into the Terzaghi Dam spillway to safely allow detailed in-chute inspection of the Terzaghi Dam spillway structure, drain maintenance, concrete repairs, and, if required, subsequent capital projects to improve the spillway.
