Executive summary

The purpose of this report is to update the Operations, Planning, Safety and Information Technology Committee of the Board of Directors on key dam risk management activities during the period from October 1 to December 31, 2024 (F2025 Q3) and to provide reasonable assurance that the safety of dams operated by BC Hydro continues to be managed to the established guidelines and criteria of the Dam Safety Program. To keep the Committee as fully abreast of the Dam Safety Program as possible, some notable developments that took place after December 31, 2024, but before the completion of this report have also been included.

Dam Safety Program Dashboard

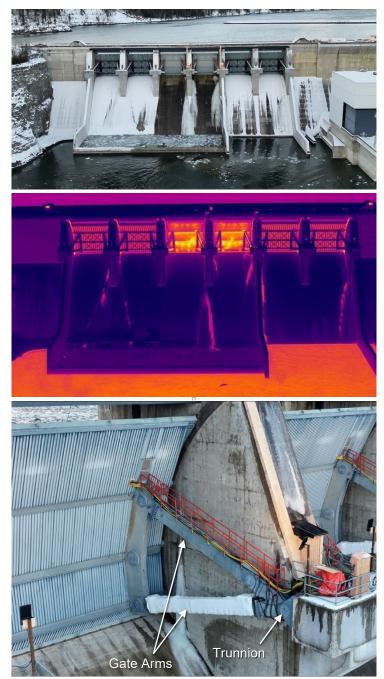
Gates 3 and 4 in the middle of the spillway are equipped with more winterization features than the other gates, having enclosed spaces with heaters to prevent ice formation on the gate body, heaters installed on the gate arms to prevent ice "bridging" between the arms and the piers, and heaters to prevent ice build-up on the trunnions around which the gates pivot to open and close. See the bottom of Figure 4, at right. These two gates alone can pass the anticipated flows, but several of their additional heaters are no longer functioning. A small project to restore those heaters has been planned but has not yet

Figure 4 Top: Peace Canyon Dam spillway following the weekly test of spillway operating gates 3 and 4 at -15C on December 23, 2024. Middle: Thermal imaging before the weekly test on December 18. Bright orange colouring indicates warmer temperatures. Bottom: Close-up of gate 4 showing the temporary heating measures that have been installed.

been released. Without proper functioning of these additional heating systems in spillway operating gates 3 and 4, satisfactory winter performance of the spillway gates to support multiple spills through the winter was uncertain at best.

- A temporary heating system to replace the non-functioning heaters in gates 3 and 4 was installed and is being operated through the winter. Glycol liquid (food safe) is heated on the dam crest and fed through lines that run down the backs of the spillway piers and are wrapped around the gate trunnions and arms. Glycol lines are also fed into the gate bodies where they feed into heat exchangers that blow warm air through the enclosed spaces. See the bottom photo of Figure 4. Thermal imaging of the spillway gates, seen in the middle photo of Figure 4, demonstrates the effectiveness of the temporary heating system.

- Temperatures at key locations in the gate bodies, on the arms and on the trunnions are being continuously monitored through Dam Safety's Automated Data Acquisition System. Warning and alarm thresholds are set, any temperature excursions below which are automatically communicated to Dam Safety personnel for investigation and response.

- Weekly inspections and tests of the two spillway gates are being conducted throughout the winter. As of the time of writing, the gates have been successfully operated in each test at temperatures as low as -15C. See the top photo in Figure 4, showing the spillway shortly after one such test.

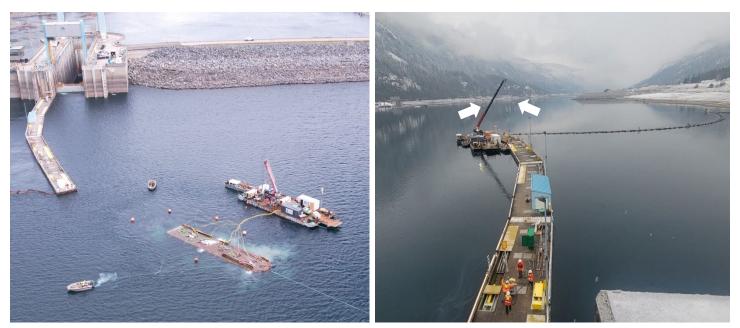
The F2020 Q4 Dam Safety Quarterly Report described the January 2020 sinking of two pontoons of the upstream floating guidewall that directs marine traffic safely into the navigation lock. The F2024 Q3 report further described how unusually low levels in the Arrow Lakes Reservoir resulted in these sunken pontoons posing a potential hazard to the remaining guidewall pontoons, requiring reorientation of the guidewall and ongoing adjustments by Stations Field Operations to protect it from further damage.

The contractor's divers worked through the fall of 2024 to prepare the pontoons for the salvage operation, during which they installed: anchorage points for towing, mooring and positioning lines; internal bracing to support the pontoon walls against differential water and air pressures; specialty valved hatches that allow air to be pumped in and water expelled from the pontoons; and external air tanks (sponsons) for additional buoyancy and stability through salvage operations. Ultimately, the two pontoons were successfully refloated and towed to temporary anchorages in the reservoir. Pontoon 6 was recovered on November 15 and Pontoon 5 was recovered on November 22, 2024. Subsequently, the guidewall was reoriented to its desired alignment on December 11, 2024. See Figure 5 on the following page.

Figure 5 Salvage operations for the two sunken pontoons of the Hugh Keenleyside Dam's navigation lock guidewall Left: Salvage of Pontoon 6 on November 15, 2024. The pontoon in the centre of the photo has just broken the surface and water is continuing to be expelled by pressurized air. The work barge is visible behind the salvaged pontoon. Right: Guidewall realigned on December 11, 2024. The refloated Pontoons 5 and 6 are anchored at the locations identified by the arrows.

Going forward, the two salvaged pontoons will be inspected to determine the scope of required repair and refurbishment. The intent is to return the pontoons to service in an upgraded guidewall, for which a separate project was initiated in Q1 of F2025.

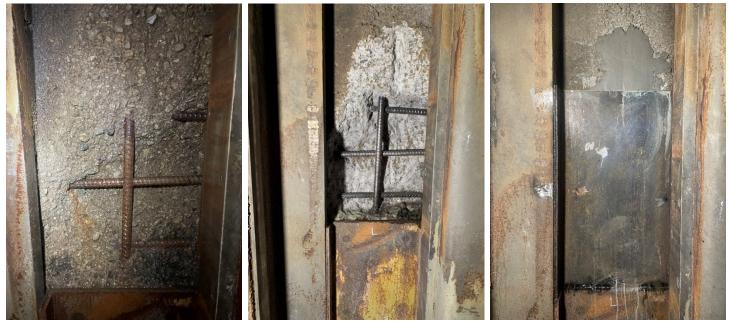
One notable maintenance project completed in Q3 was the Terzaghi Low Level Outlet Gate #1 guide repairs. Inspections had identified concrete deterioration and exposed reinforcement within both sides of the gate guide slots. Continued and unabated deterioration of the concrete would eventually have undermined the support for the gate guides, allowing them to deform, and potentially lead to the gate becoming jammed and nonfunctional. Executed by the Construction Services Mechanical Specialty team, this project repaired the slots by installing steel plates and backfilling the deteriorated areas with concrete. It required extensive planning to coordinate outage requirements with Stations Field Operations, to establish safe access into the confined space using a crane truck and personnel basket, and to implement rope access measures for provision of worker rescue. The work was completed within schedule and budget. See figure 6 below.

Figure 6 Terzaghi Low Level Outlet Gate #1 guide repairs. Left: Concrete deterioration with exposed reinforcement in the guide slot. Middle: Completed removal of delaminated concrete, surface preparation, and rust cleaning from the reinforcement. Right: Welded steel plate installed in the slot, with the concrete void backfilled.

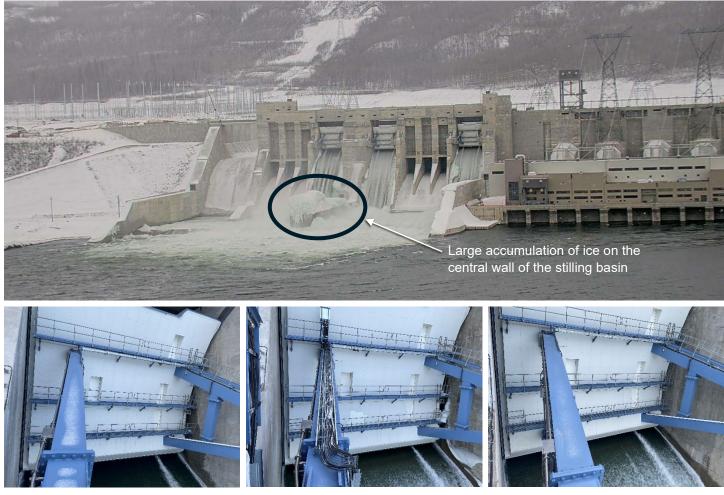
With only two of the six generating units in service, water is being continuously spilled this winter, which is not typical of future planned operations and is putting the winterization of the gates to an extreme test. Figure 8 shows the spillway on January 17, 2025. There are large accumulations of ice on the concrete structures – particularly of the central wall – of the stilling basin downstream of the spillway. In these locations, the ice does not interfere with the spill or gate operations. In contrast, the three spillway gates are essentially free of ice. The gate bodies, trunnions, trunnion arms, gate sills, and gate guides are equipped with heaters, the gates are operated daily to break any ice formations along the gates' edges, and the gates are opened by 3-4 metres each week to allow water flows to melt and wash away ice accumulations along the pier walls. These provisions have been effective and have informed the measures taken to winterize the spillway gates at Peace Canyon Dam, described in "New Issues" on pages 6 and 7 of this report.

Figure 8 The spillway and spillway operating gates of Site C Dam during winter spill operations. Top: Overview of the spillway showing the very large accumulation of ice on the stilling basin's central wall. Bottom: From left to right, spillway operating gates 3, 2 and 1, showing the absence of accumulated ice on the gates and piers, and demonstrating the effectiveness of the installed heating and operational measures to remove ice.

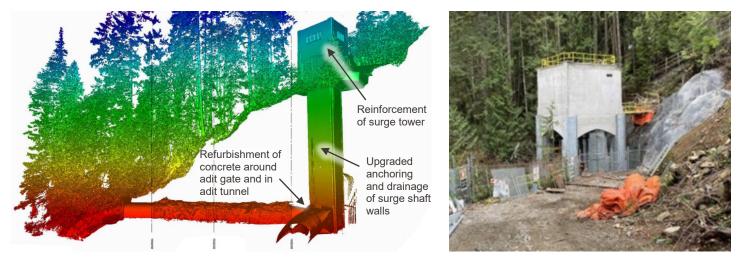
The spillway of Alouette Dam would be damaged in a major earthquake – one with ground motions expected to occur at that location once every 1,000 to 2,500 years – so that post-earthquake regulation of the Alouette Lake Reservoir would rely upon the continued functioning of the tunnel that conveys water to Stave Lake from the north end of Alouette Lake (the Alouette-Stave Tunnel). But that tunnel and its ancillary gate control structures and equipment were constructed in the 1920s and would not withstand even a moderate earthquake. This project is being undertaken to seismically upgrade the tunnel and its associated infrastructure so that it can reliably convey and regulate the flow of water from Alouette Lake into Stave Lake after undergoing earthquake ground motions that are expected to occur there only once every 10,000 years.

Figure 9 Civil engineering scope of seismic upgrades on the Stave Lake (downstream) end of the Alouette-Stave tunnel within the Alouette Headworks Tower and Surge Tower Seismic Upgrade project. Left: A three-dimensional point cloud indicating the extent of the upgrades to the surge tower, the surge shaft, and the adit tunnel. Right: Completed seismic reinforcement of the surge tower.

The project has been staged to first complete the upgrades on the Stave Lake end of the tunnel, where the gate that regulates tunnel flows is located. This first stage of work includes upgrades to the structures and equipment that enable operation of the "adit gate" that regulates flow through the tunnel. The civil scope – structural upgrades to segments of tunnel linings, the surge shaft and surge tower above, site preparation and foundations for control and backup power enclosures, and stabilization of adjacent slopes – was completed in Q3. See Figure 9, below.

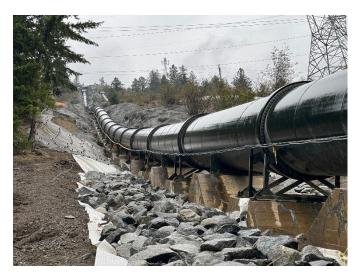
There are four steel penstocks at Bridge River 1 Generating Station that convey water down a steep mountain slope to the four 50-megawatt generating units. Over the seventy years since the penstocks were built, loose rock had sloughed down the slope and covered more than forty percent of their concrete foundations. Of the foundations that were visible, inspections revealed widespread concrete pedestal cracking, structural support anchor bolt deterioration, and damage to the sliding supports that allow for thermal expansion of the penstock sections; all of which potentially compromised the structural integrity and service life of the penstocks. This project was initiated in F2021 Q4 to remove the rock debris, locally stabilize the slopes adjacent to the penstocks, refurbish adjacent retaining structures to contain and divert rock debris from the penstocks, and refurbish the concrete foundations and steel penstock supports. The project was put In Service on October 31, 2024, ahead of the target milestone date of January 25, 2025, and is forecasting to be \$5 million under the \$70.2 million budget.

Figure 10 Completed slope improvements and foundation refurbishment on one of the four penstocks at Bridge River 1 Generating Station.

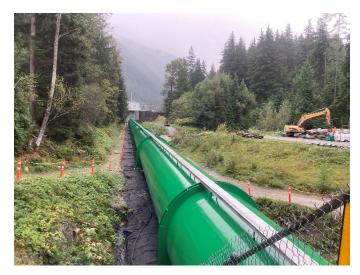
Figure 12 Recoated penstock at Lake Buntzen 1 Generating Station.
