## **Columbia River Project Water Use Plan**

### **Kinbasket and Arrow Reservoirs Revegetation Management Plan**

### **Debris Mounds and Wind Row Construction Pilot Program**

### **Implementation Year 7**

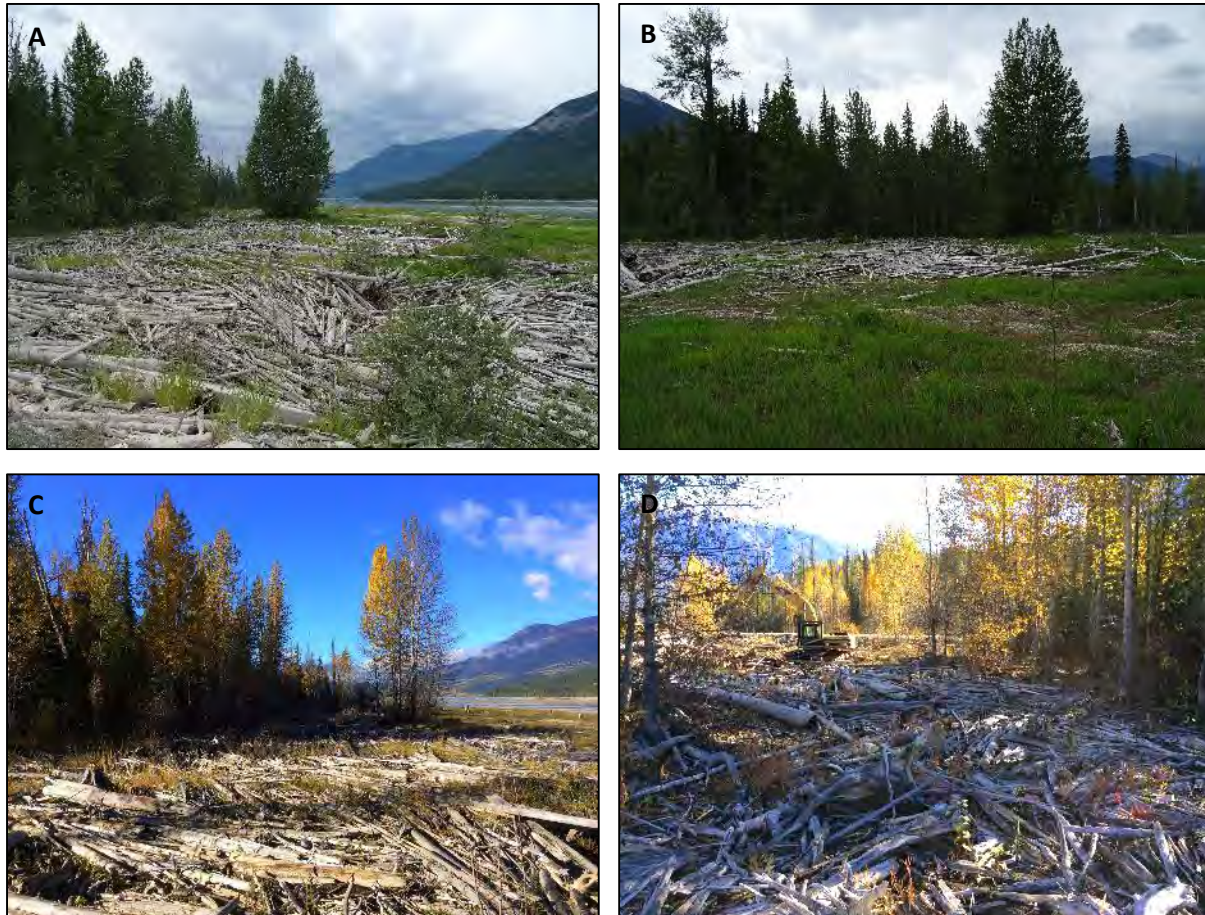
Figure 4-1: Examples of vegetation cover and wood debris distribution at the Bush Arm Causeway South site prior to construction in summer 2015 (A and B) and during construction in the fall (C and D). Summer photos dated July 15, 2015; fall photos dated Sept. 28, 2015.

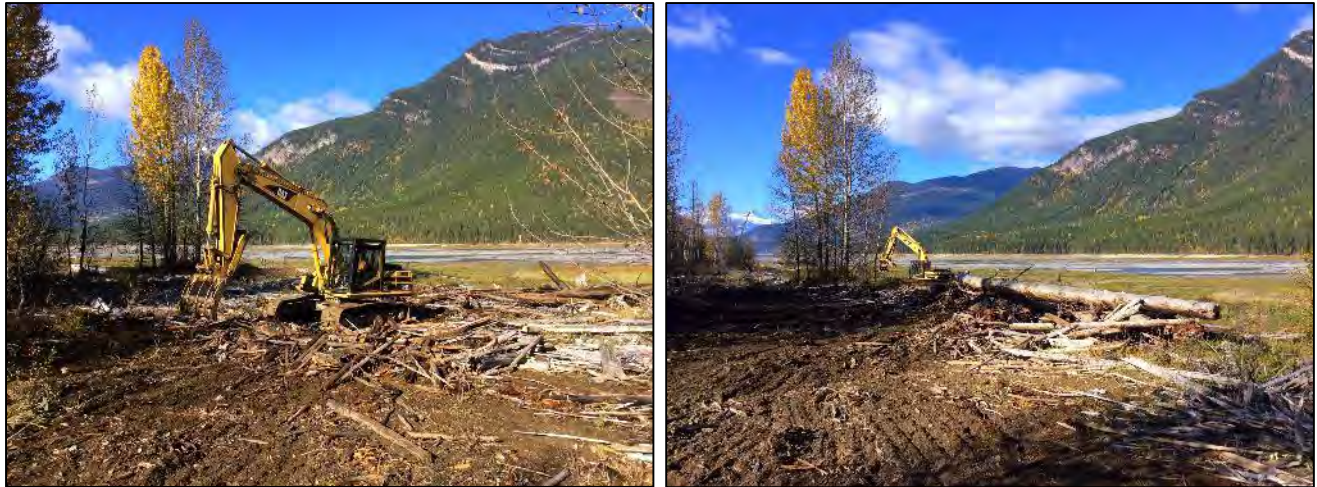
**Figure 4-2: Removing wood debris and sorting large logs at the Bush Causeway South site, September 28, 2015.**

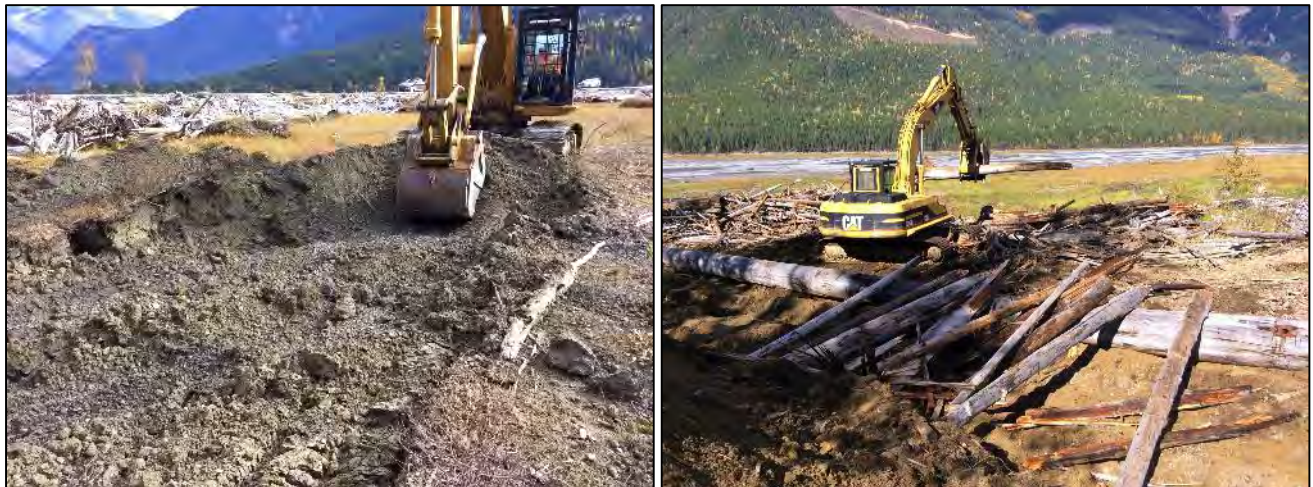
**Figure 4-3: Excavating the 'nest' for the sill logs and fill (left) and placing the sill logs and perpendicular base logs at the mound at Bush Arm Causeway South.**

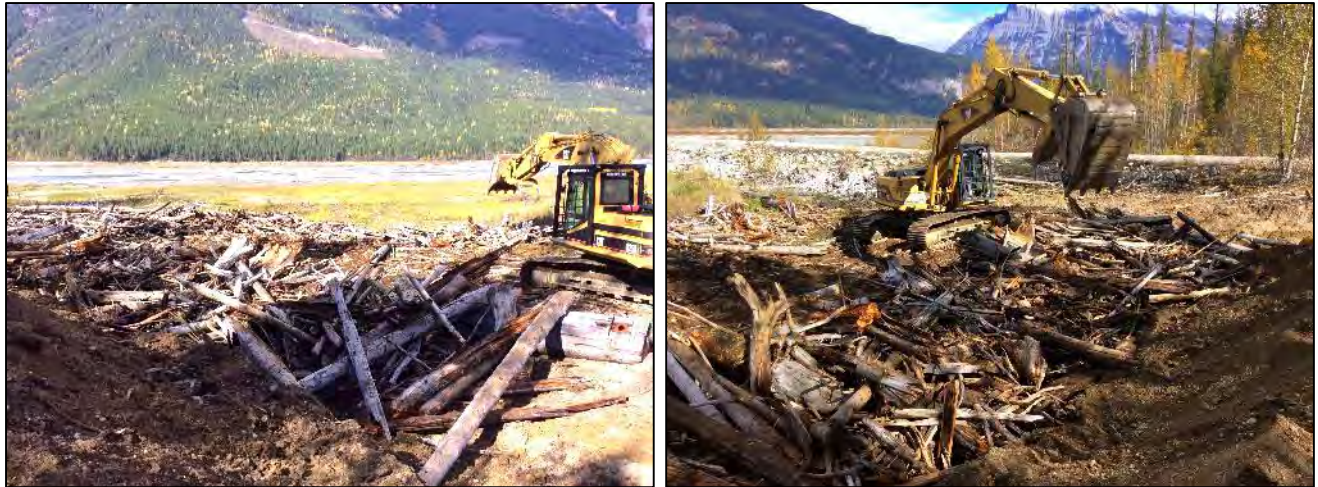
Figure 4-4: Filling the 'nest' with smaller logs, debris and soil.

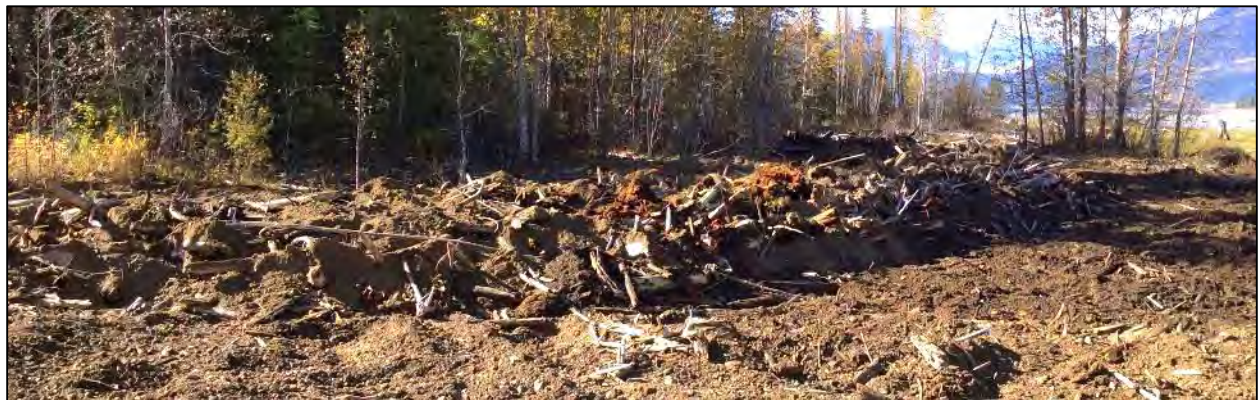
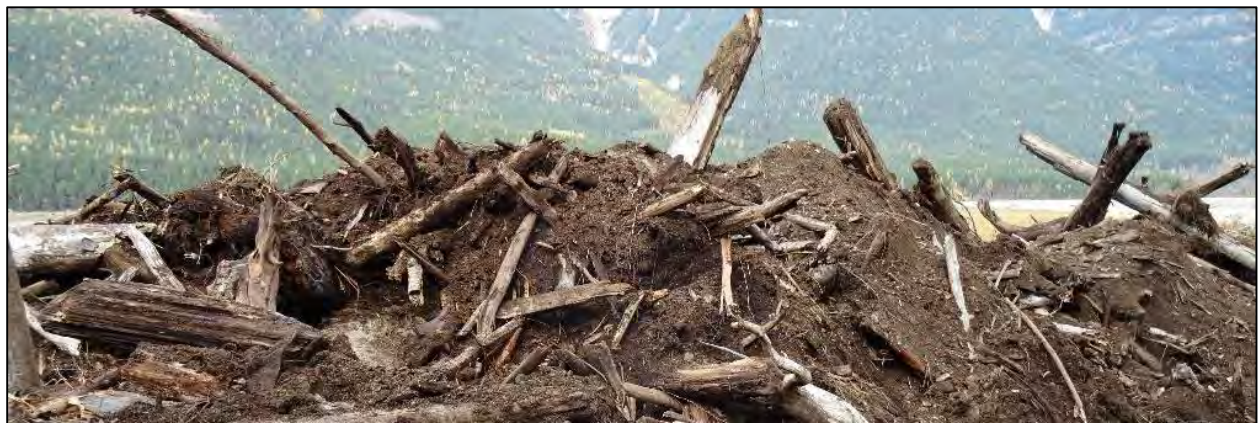
Figure 4-5: The completed mounds at the Bush Arm Causeway south location showing the matrix of substrate and woody debris with a rough surface.

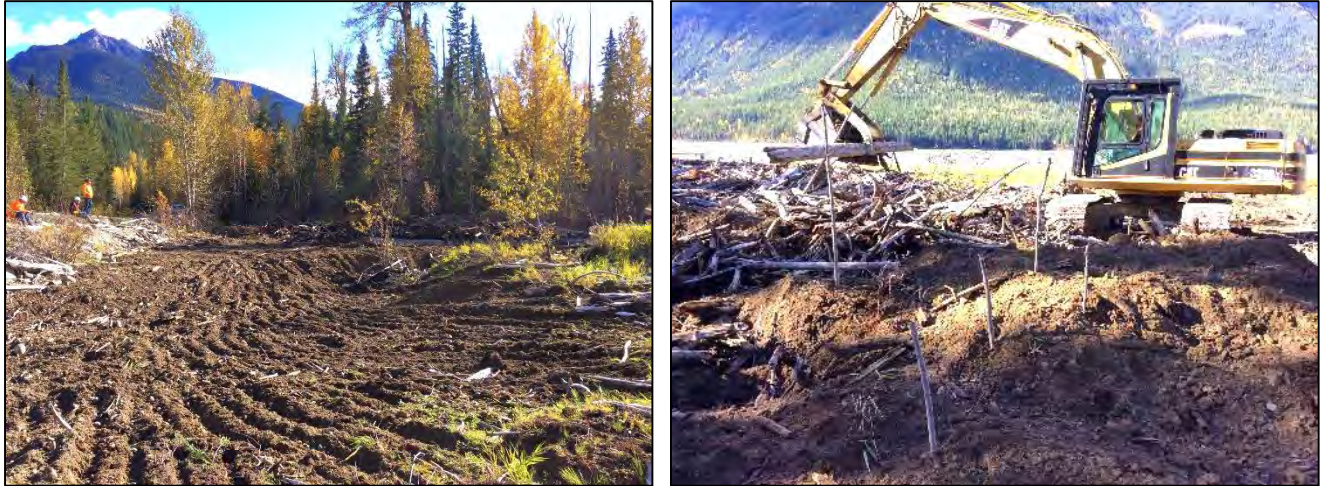
**Figure 4-6:** Land following de-compaction and furrowing to promote the re-establishment of vegetation at the Bush Arm Causeway South location (left) and live stakes planted in one of the mounds (right).

- 5. Site cleanup and live-staking.** Following mound creation, the area cleared of woody debris was treated to remove compaction areas and the soil was loosened and furrowed to promote vegetation regrowth (Figure 4-6). Live stakes were planted throughout the mound (n = 48; Figure 4-6). Stakes were mainly black cottonwood (two were red-osier dogwood). The depth, height above ground, and diameter of each stake was measured to determine if these variables affected regrowth (Figure 4-7). The performance of the live stakes will be assessed in spring 2016.

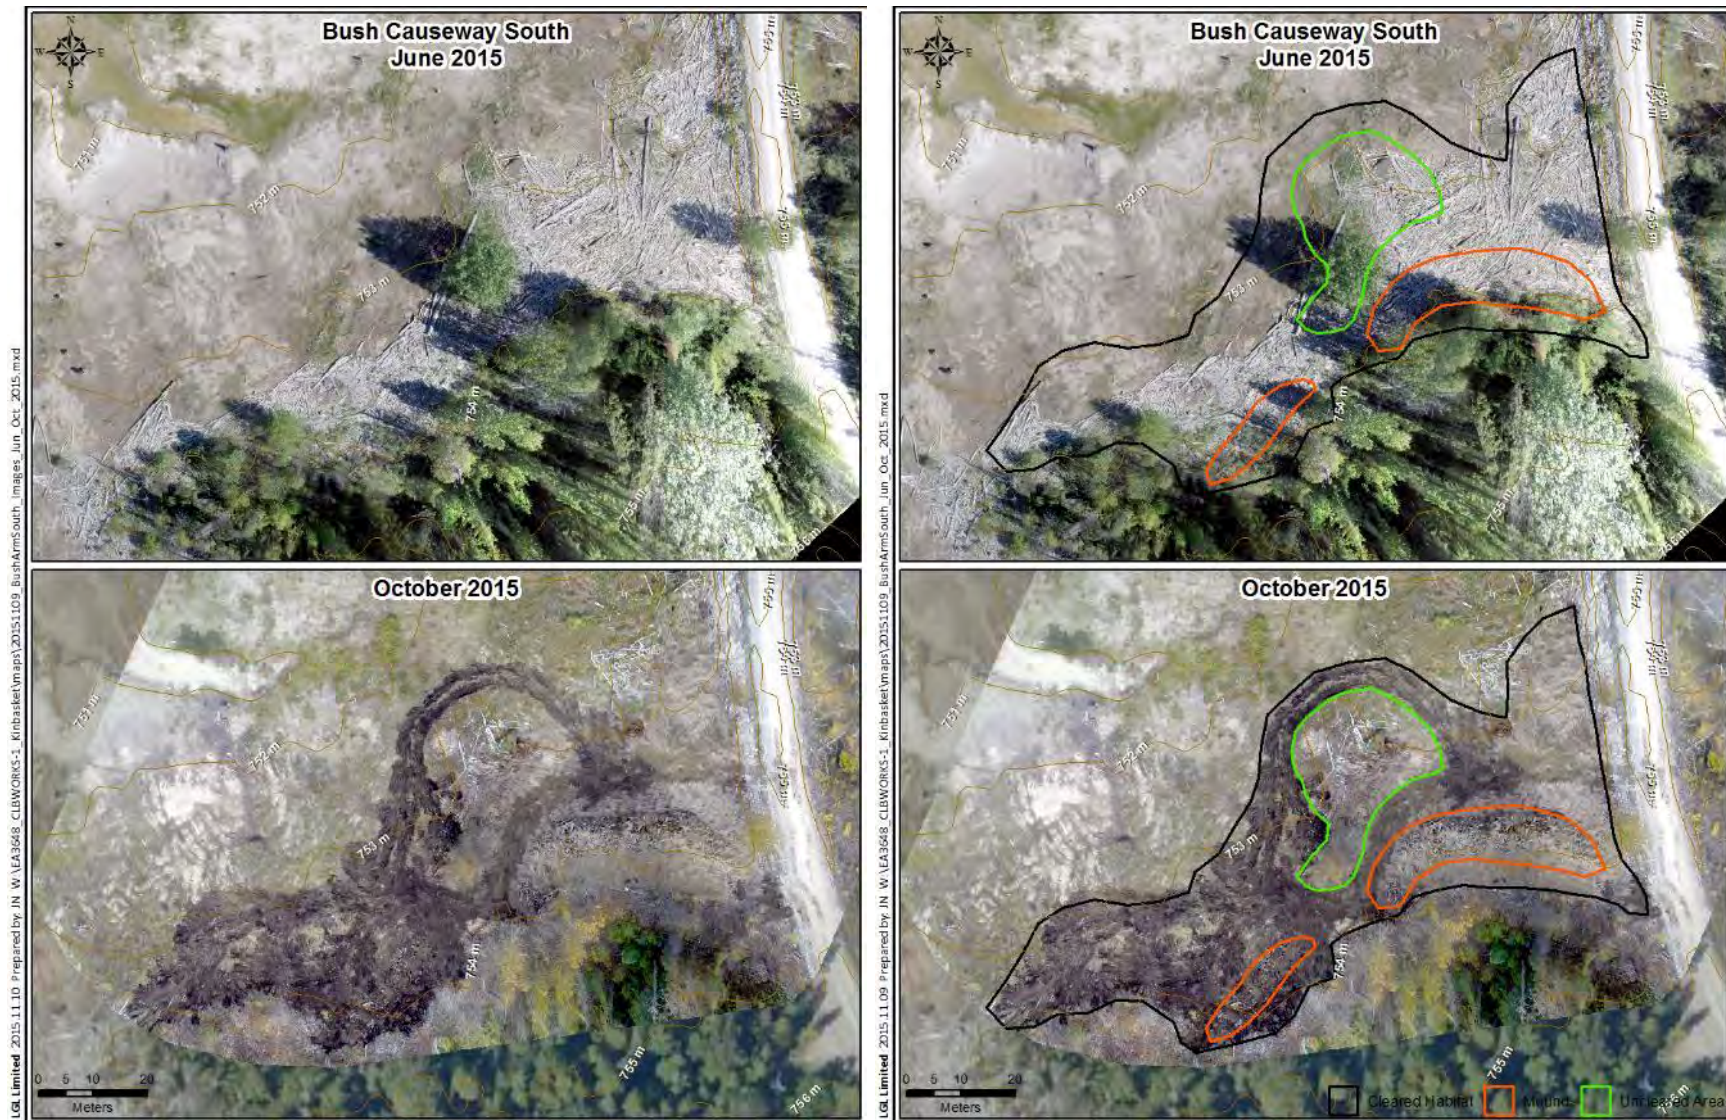
**Figure 4-9:** The Bush Causeway South site prior to construction (top left) and following clearing and construction of the mounds (bottom left). The addition of polygons delineating the area cleared, the area not cleared, and the two mounds is provided for context (top right, bottom right). Images obtained via drone (operated by Murray Chapple, Sterling Lumber)

- 8. As-Built:** The total area manipulated was 4,119 m<sup>2</sup>, resulting in the creation of two mounds; the removal of wood debris from 2,999 m<sup>2</sup> of land; and the incorporation of 572 m<sup>2</sup> of existing habitat (Table 4-1). The two mounds created were 134.6 m<sup>2</sup> and 413.1 m<sup>2</sup>. The larger mound was situated between 753.2 m and 754.5 mASL with an average height of 1.5 to 2 m above ground. The smaller mound was similar in height and was built between 753.5 and 754.4 mASL. Aerial imagery of the Bush Arm Causeway site before and after construction is provided in Figure 4-9.

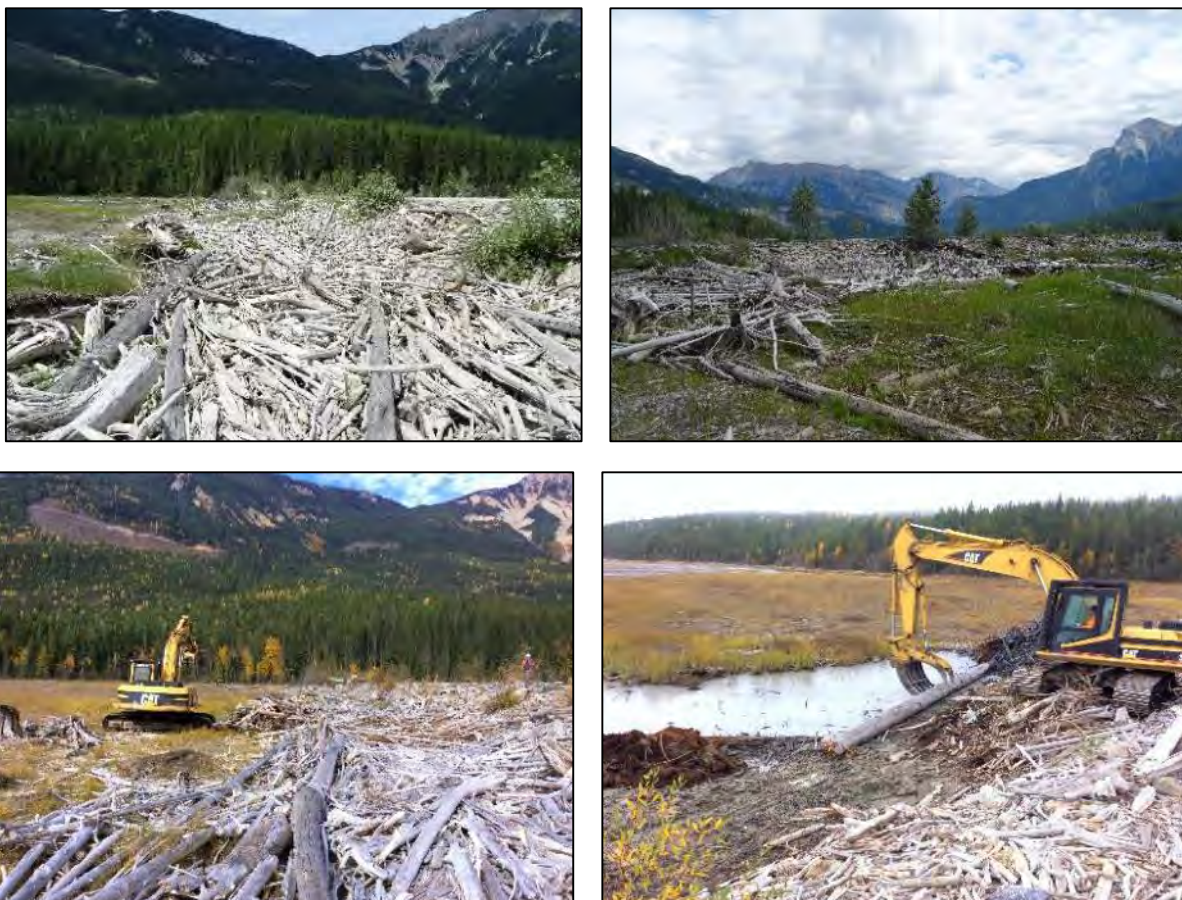
**Figure 4-10: Examples of vegetation cover and wood debris distribution at the Bush Arm Causeway North site prior to construction in summer 2015 (top panel) and during construction in the fall (bottom panel). Summer photos dated July 15, 2015; fall photos dated Sept. 30, 2015.**

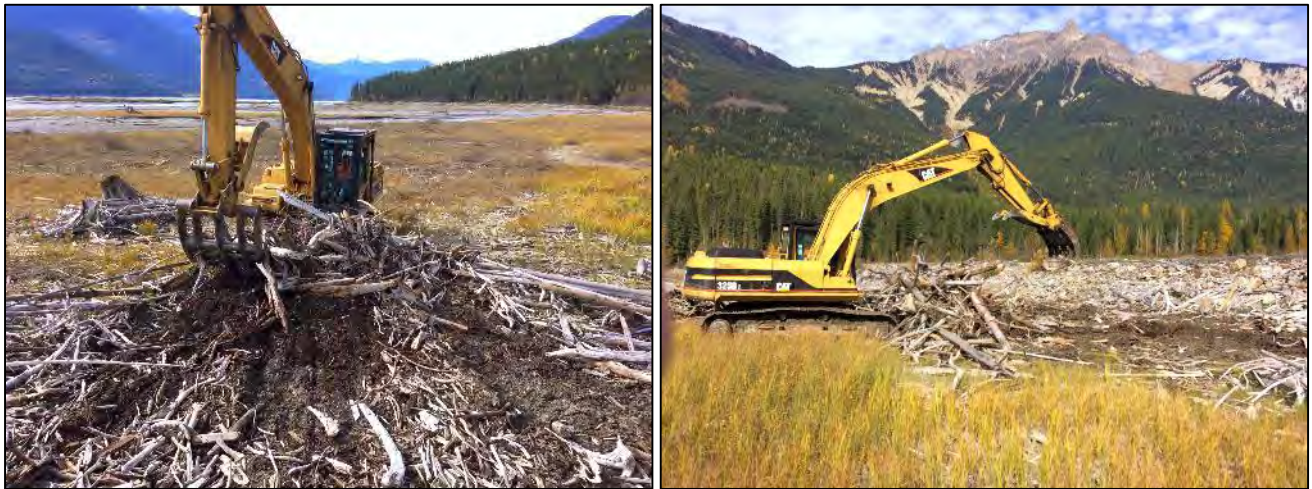
Figure 4-11: Removing wood debris and clearing the ground at the Bush Causeway North Site, September 29, 2015.

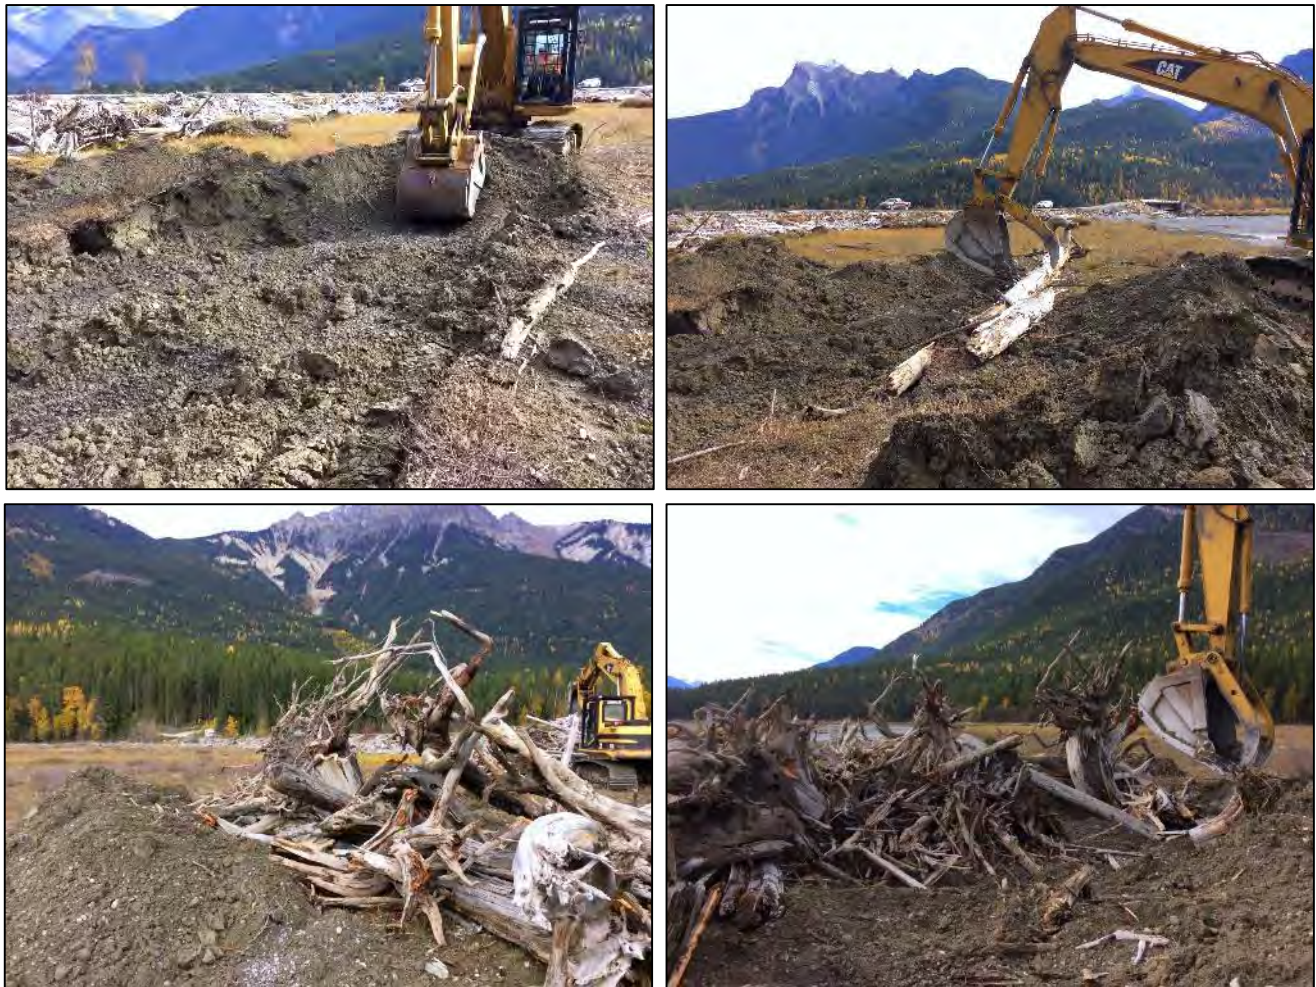
**Figure 4-12: Excavating the 'nest' for the sill logs and fill, and placing the sill logs and anchoring the root wads are log logs by back filling the area behind the root wad.**

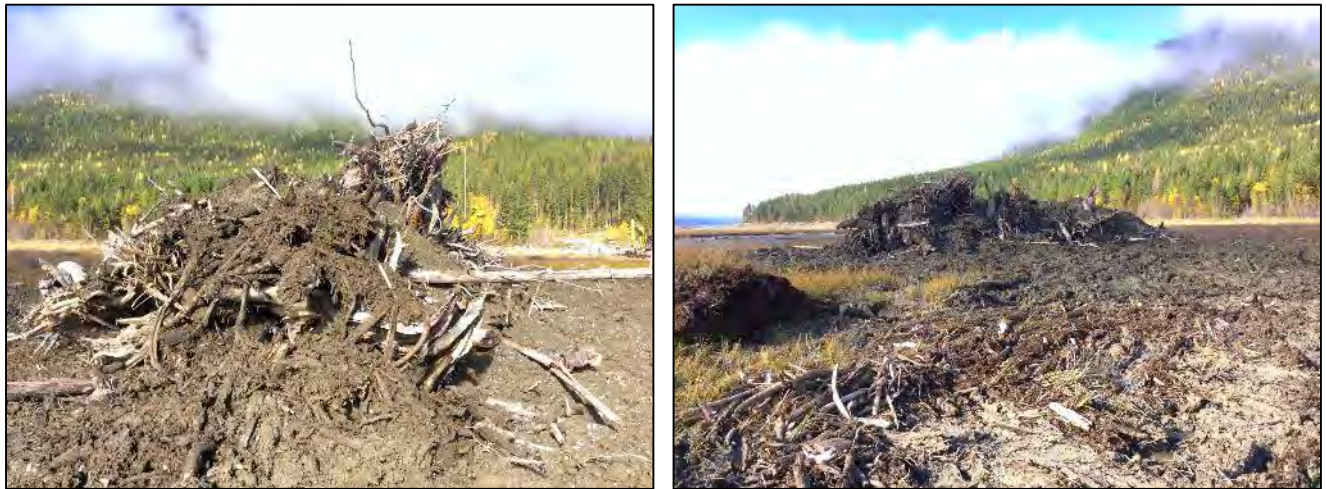
Figure 4-13: Covering the mound with smaller logs and substrate excavated from the site.

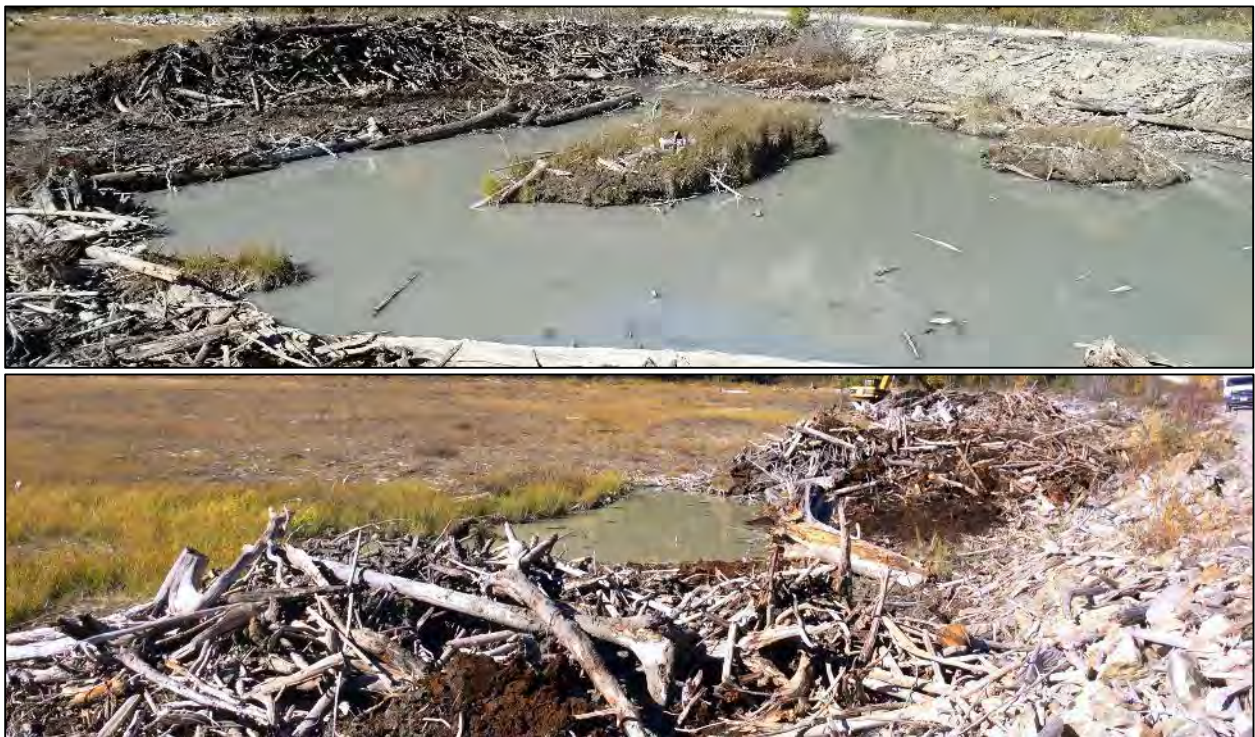
Figure 4-14: Some of the completed mounds at the Bush Arm Causeway north location showing the height of the mounds relative to the existing causeway. In this locations mounds were built perpendicular and parallel to the existing roadbed.

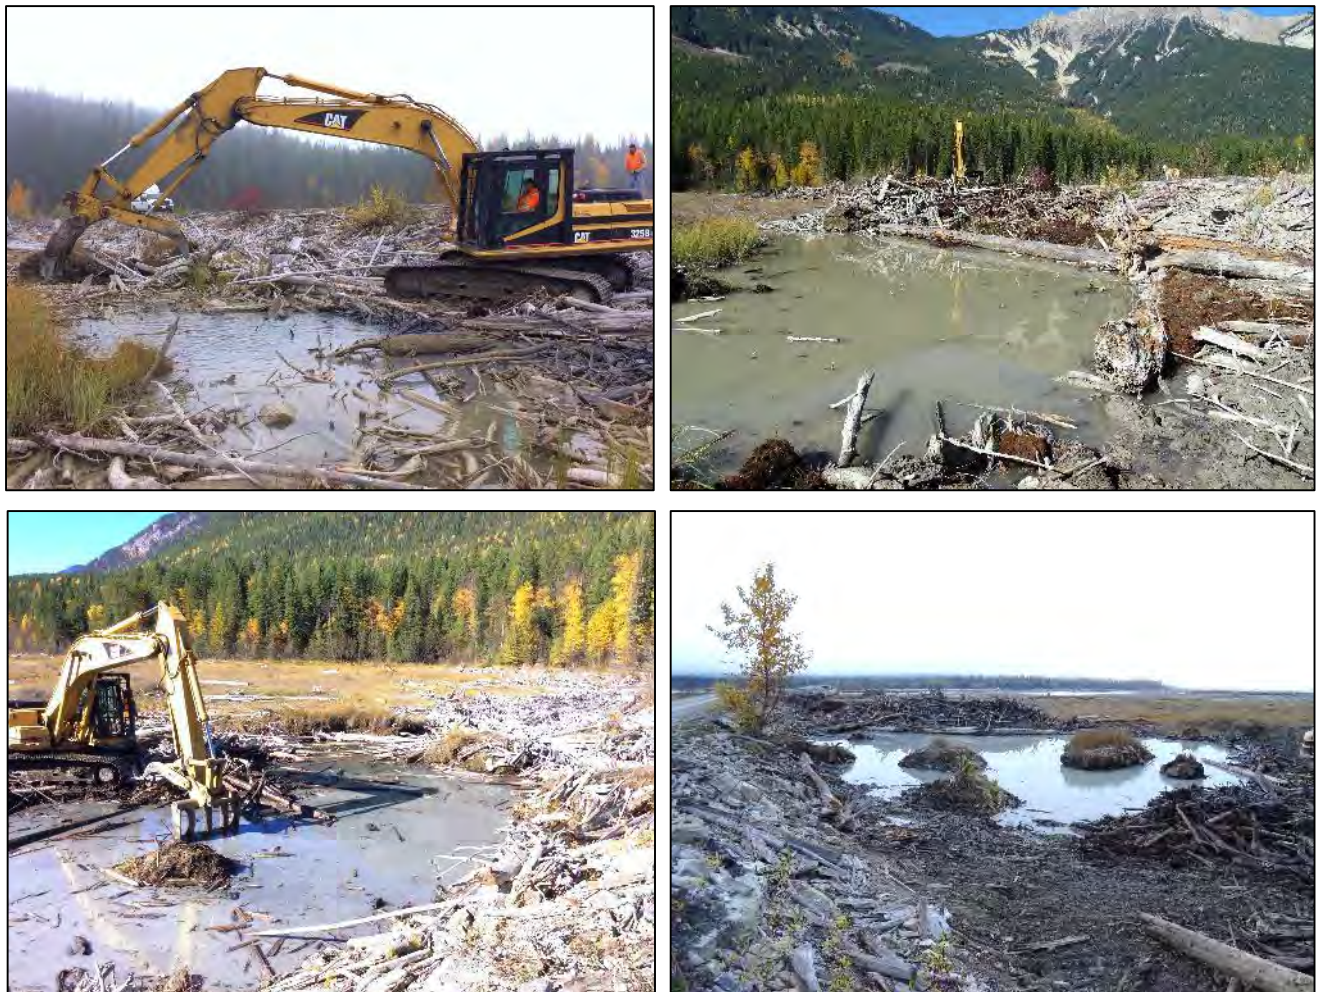
**Figure 4-15:** Before and after photos of pond clearing and cleanup at the Bush Arm Causeway north location. Note the positioning of a large sill log in the top right. The bottom panels are of the same pond, but from different perspectives to show the wood accumulation (bottom left) and cleaned pond (bottom right) with the retention of peat islands

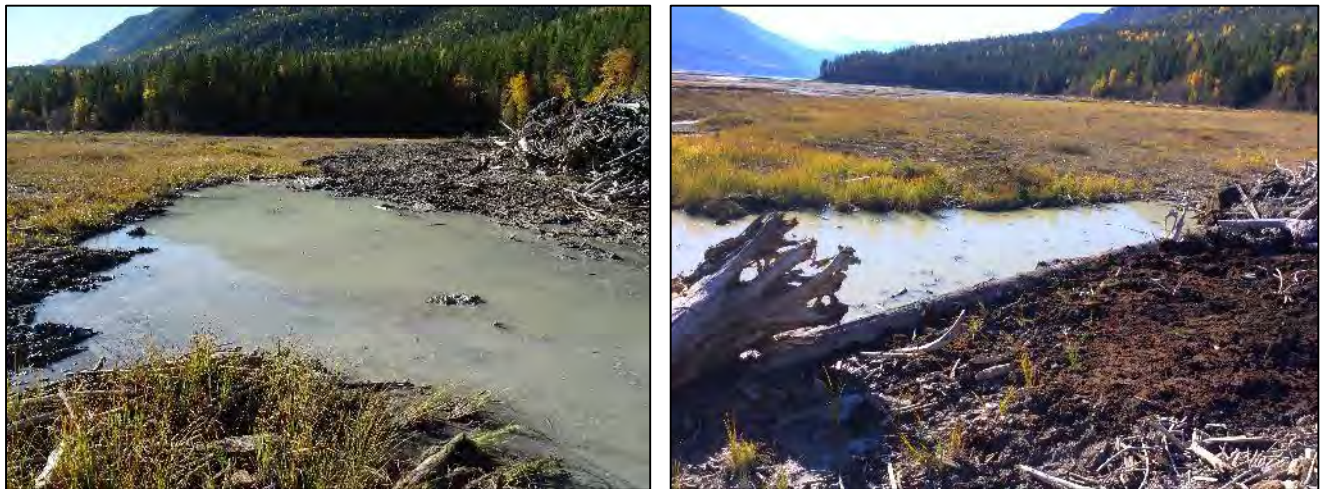
**Figure 4-17: Completed physical works at Bush Arm Causeway North showing a cleaned pond (left) and land prepared the re-establishment of vegetation (right, foreground)**

- 6. Site cleanup.** Following mound creation and pond cleaning, the area cleared of wood debris was treated to remove compaction areas and the soil was loosened and furrowed to promote vegetation regrowth (Figure 4-17).

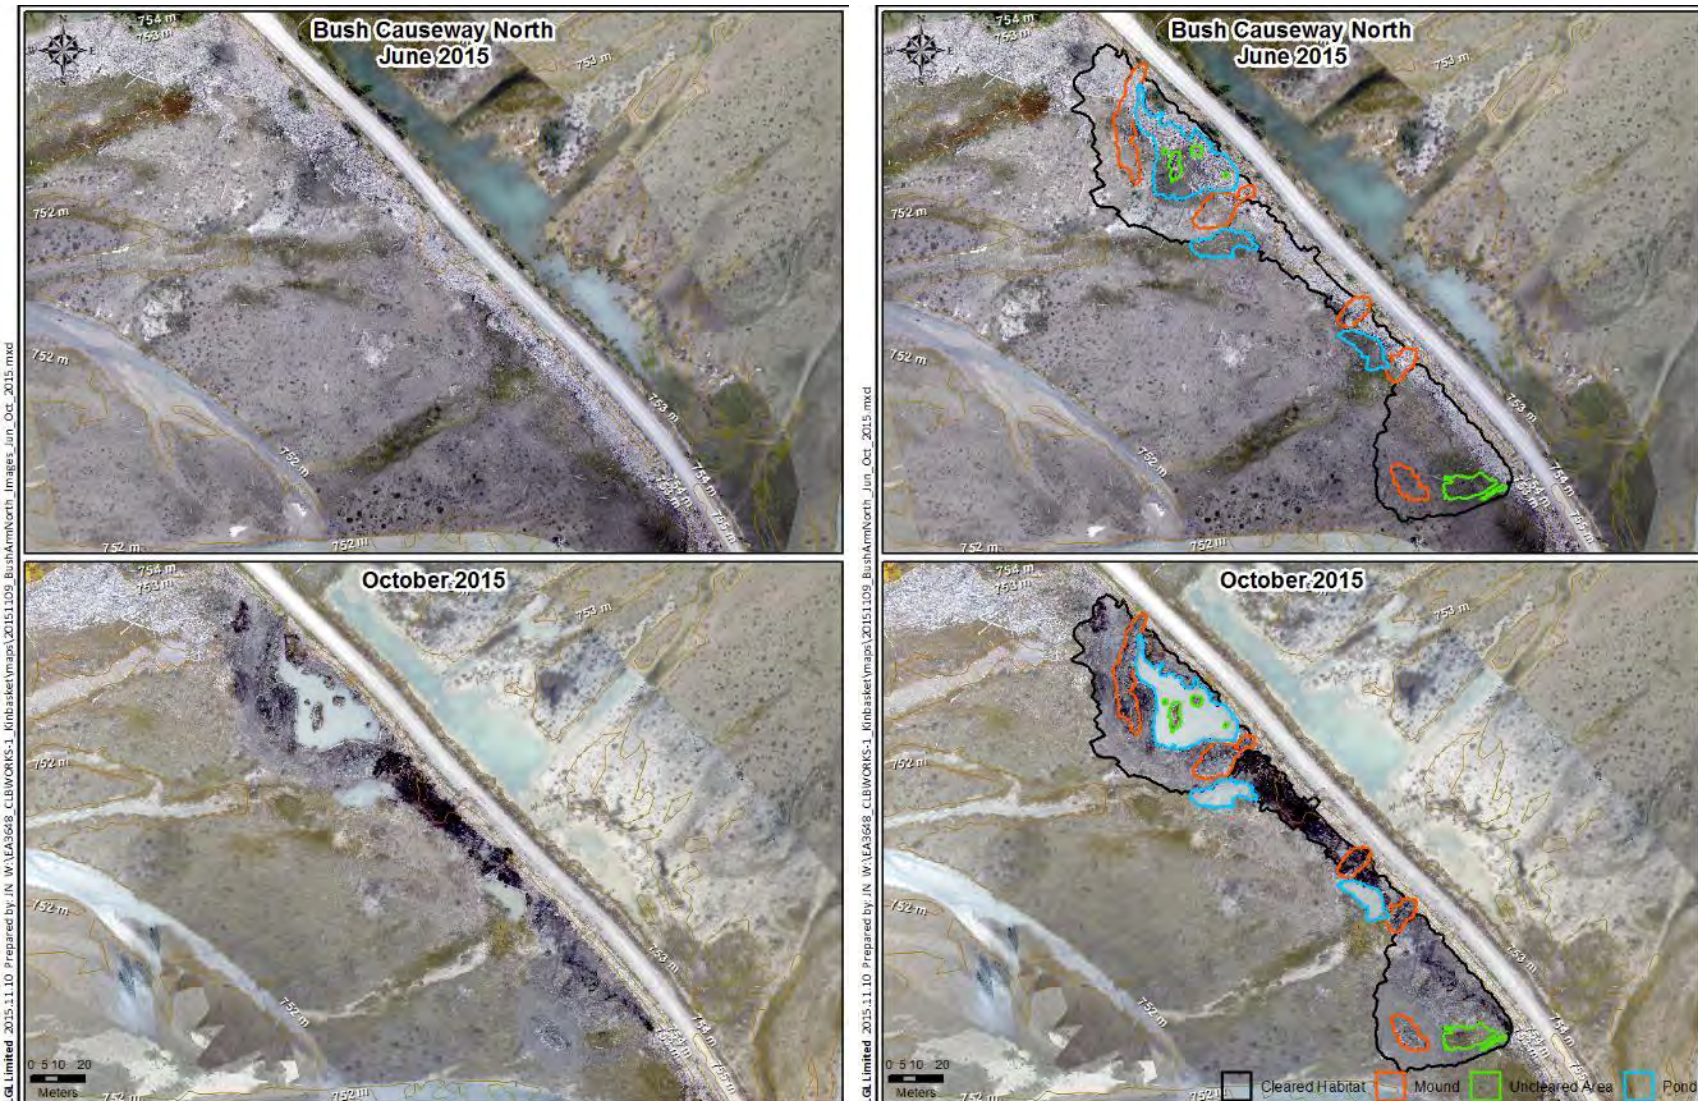
**Figure 4-18: The Bush Causeway North site prior to construction (top left) and following clearing and construction of the mounds (bottom left). The addition of polygons delineating the area cleared, the area not cleared, the mounds, and ponds is provided for context (top right, bottom right). Images obtained via drone (operated by Murray Chapple, Sterling Lumber)**
