## 7.0: Quarterly Dam Safety Report

The purpose of this report is to update the Operations, Planning, Information & Technology Committee of the Board of Directors on key dam risk management activities during the period from January 1 to March 31, 2024 (F2024 Q4) and to provide reasonable assurance that the safety of dams operated by BC Hydro continues to be managed to the established guidelines and criteria of the Dam Safety Program. To keep the Committee as fully abreast of the Dam Safety Program as possible, some notable developments that took place after March 31, 2024, but before the completion of this report have also been included.

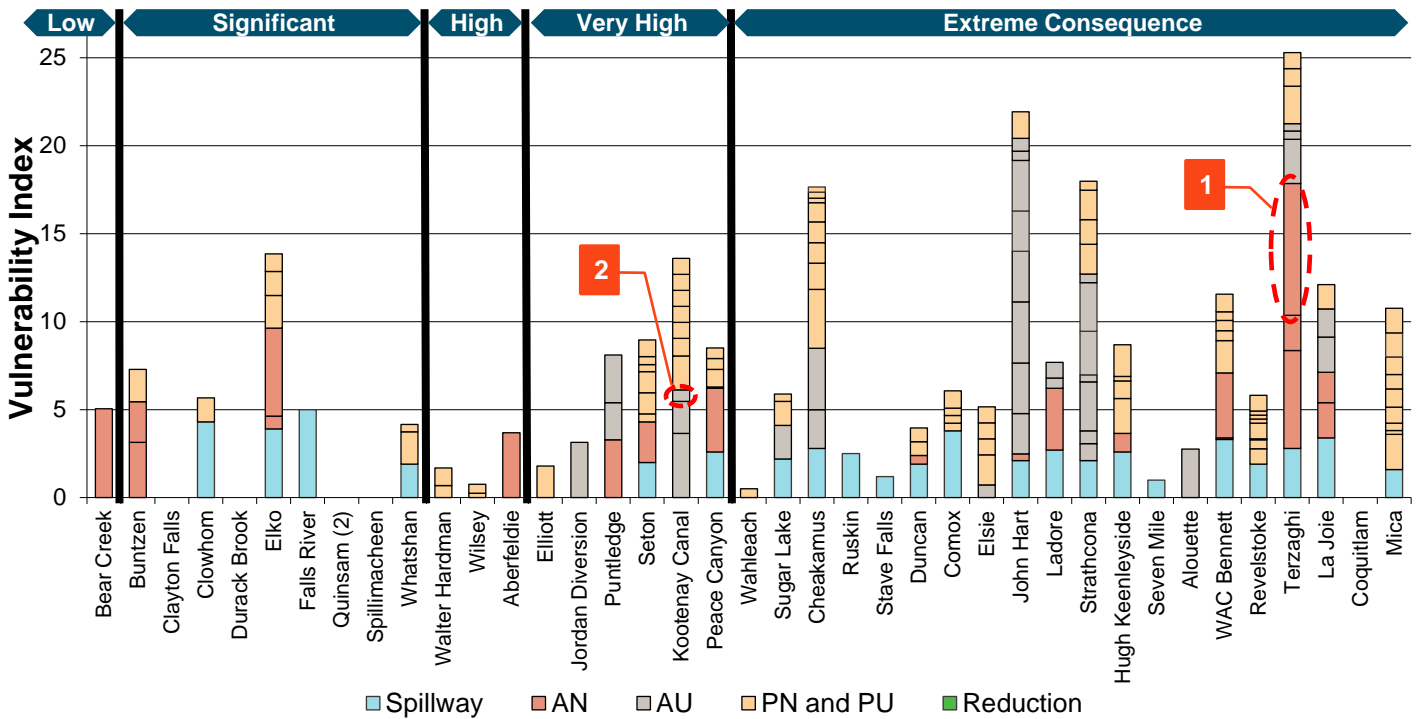
Identified physical deficiencies in BC Hydro’s dams and the degree of concern that exists with respect to their impact on the integrity and performance of the dam are characterized by the Vulnerability Index. The higher the value of the Vulnerability Index (scale of 0-10), the higher the likelihood of that deficiency leading to poor performance. The Vulnerability Index for each identified issue at each dam site is shown in Figure 1. Vulnerability Indices for the individual deficiencies are aggregated into stacked bars for each dam, and dams are sequenced from left to right in order of increasing downstream consequences per the BC Dam Safety Regulation. Changes in Vulnerability Index for actual and potential deficiencies (including those related to spillway reliability), aggregated across the entire fleet of dams, are tracked on a quarterly basis and shown in Figure 2. Notable changes in Vulnerability Index in F2024 Q4 are identified in Figure 1 and described below.

**Figure 1** Dam Safety overall risk profile at the end of F2024 Q4, as represented by the Vulnerability Index. Changes this quarter are indicated by the numbered boxes.

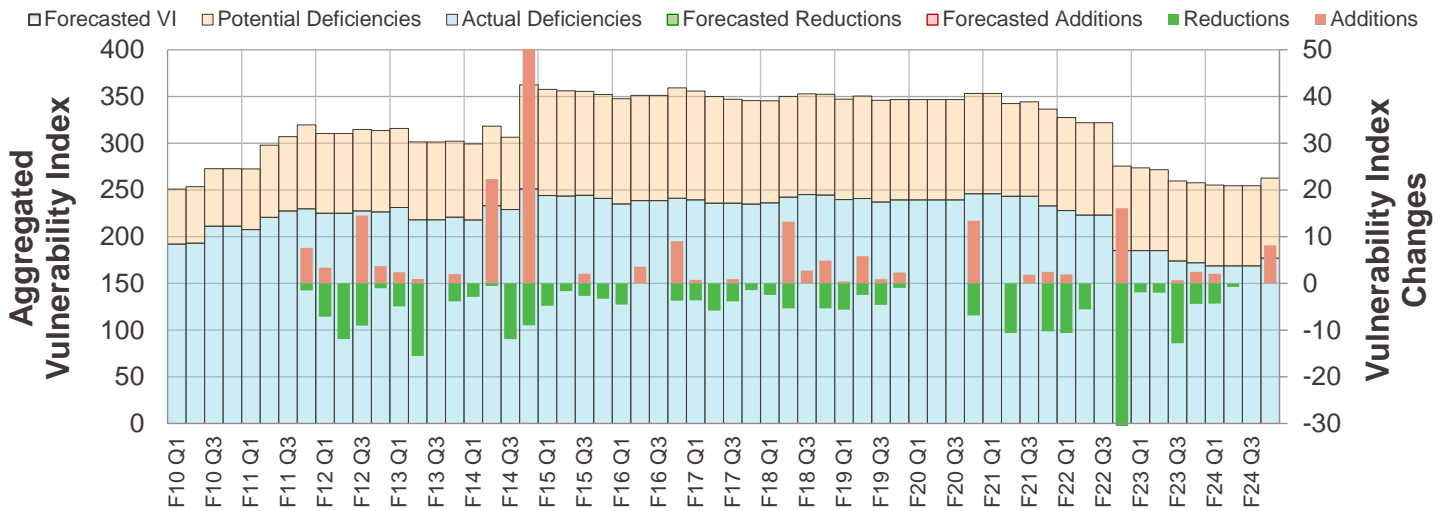
**Figure 2** Historical and forecast changes and trends in the Vulnerability Index aggregated across the BC Hydro system.

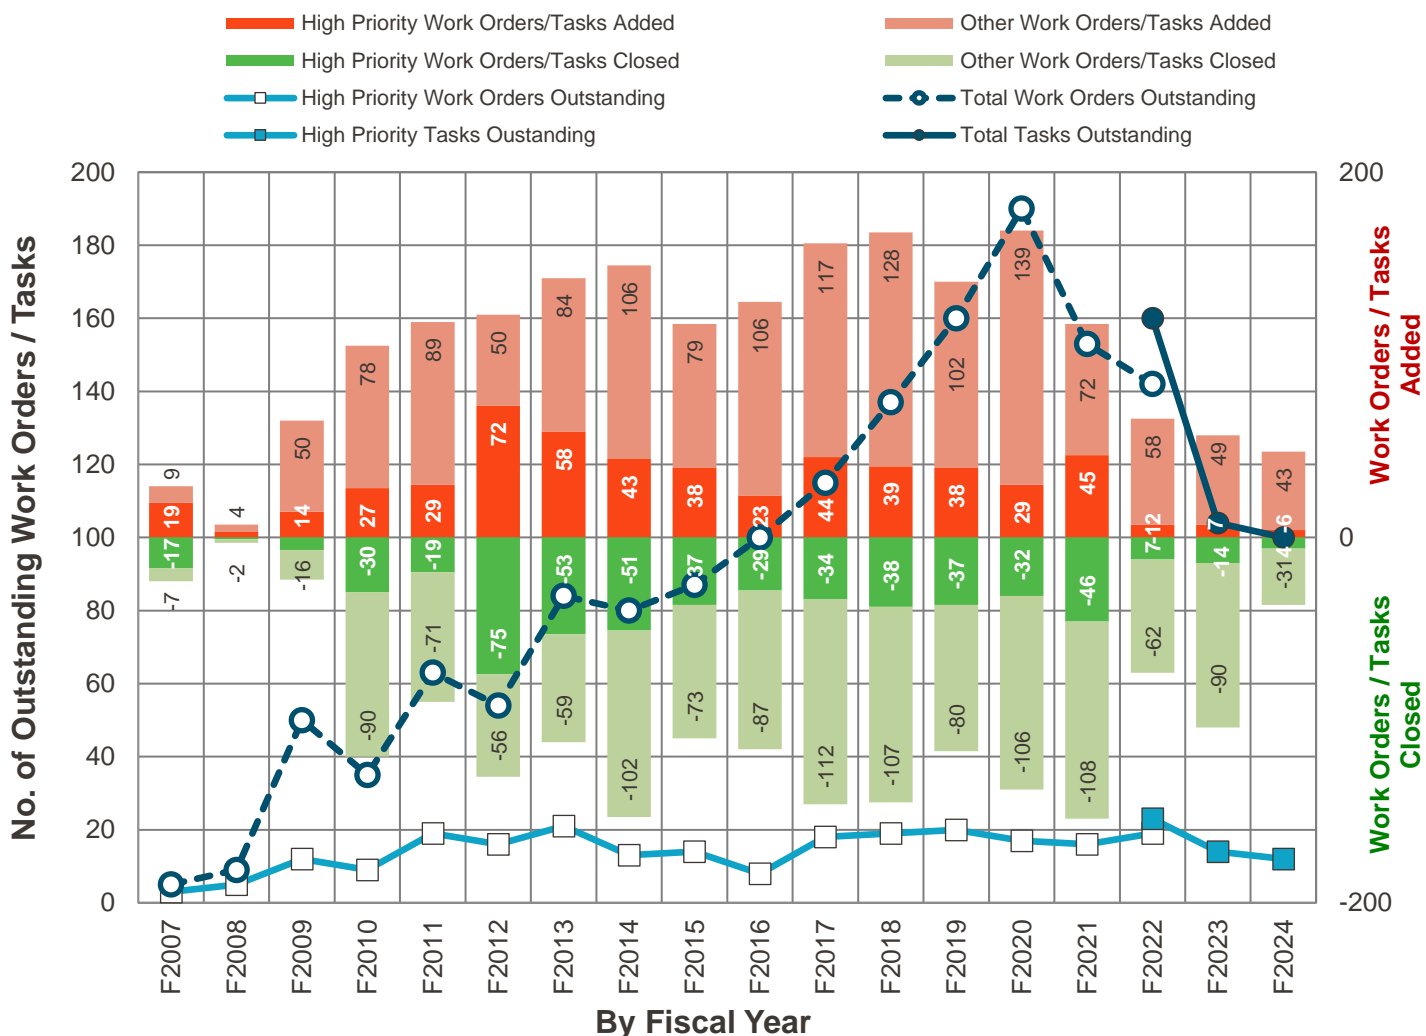
The number of outstanding gate maintenance tasks is shown in the chart in Figure 7. Following significant decreases in each year from F2020 through F2023, the inventory only decreased slightly this year; from 104 outstanding tasks at the end of F23 to 100 at the end of F2024.

priority tasks at the end of F2024 was 12; an increase from 9 in Q4 but a decrease from 14 from F2023. Eight of these outstanding high priority tasks are included in the F2025 maintenance plan. The other four high priority tasks cannot be completed in F2025 but have been reviewed and can safely be deferred to a future year.

**Figure 7** Number of outstanding corrective and condition-based spillway gate maintenance work orders and tasks, new work orders and tasks added, and work orders and tasks closed as at the end of each previous fiscal year.
